Manhole Inspection Summary

Manhole # S25CC_038MH

Insp Date: **7/19/07 11:17 AM**

Location Address: **1100 RIGGS AVE**

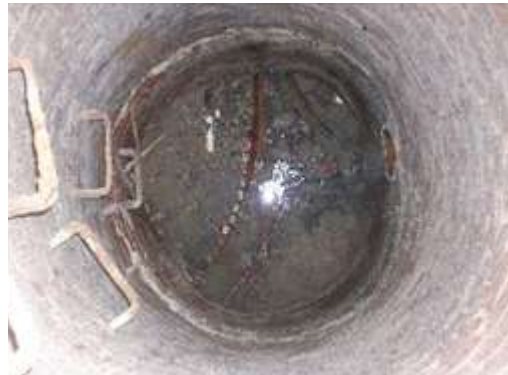
Top View

CORRODED STEPS AND DEBRIS IN BENCH AND CHANNEL

abandoned pipe at i7

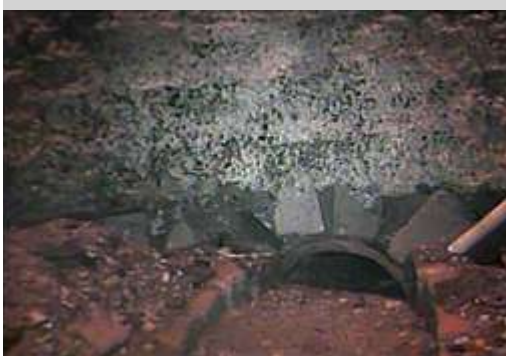
Defect 2

Condition: ☐ Sound ☐ Cracked ☐ Root Intrusion ☐ Loose Brick ☒ **Deteriorated**

DETERIORATED CHIMNEY

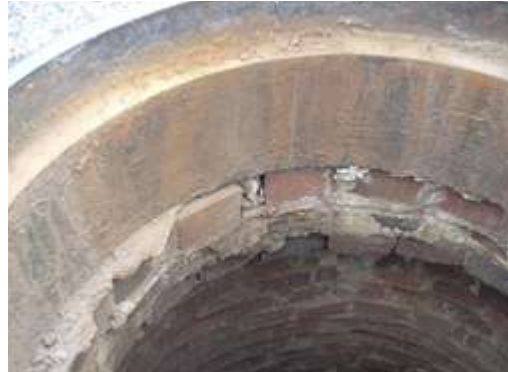
Defect 4

Surcharge ☒ **Evidence Of Surcharge** Depth: **4** (ft.) ☐ Active Surcharge Present

SURCHARGE EVIDENCE ON BARREL WALL AND STEP

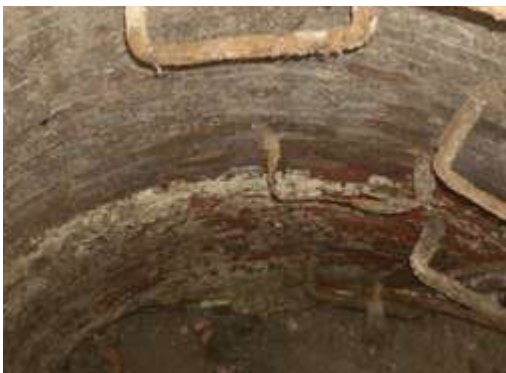
Defect 3

Steps Count: **7** Missing: **0** ☒ **Corroded**

CORRODED STEPS

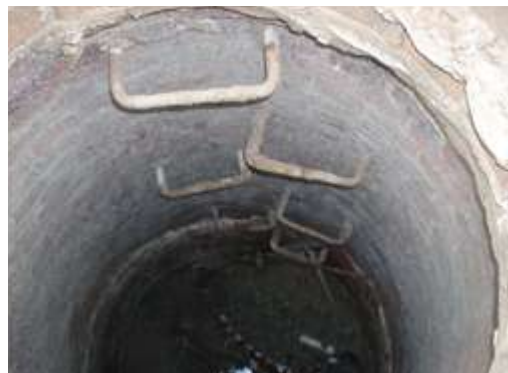
Defect 1

Frame Offset: **3** (in.) Condition: ☒ Sound ☐ Cracked ☐ Leaks

FRAME OFFSET

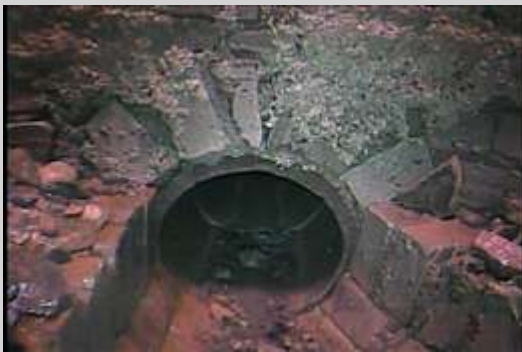
12 O'Clock Outflow

Pipe Height: **8.4** (in.) Rod and Bar (Angled)
Pipe Material: **Clay** ☐ Pipe Lined
Invert Depth: **11.09** (ft.) Flow Characteristics: **None**
Deposits: ☐ None ☐ Mud ☐ Sludge ☒ **Debris** ☐ Grease
Silt Depth: **1** (in.) Deposits Extent: **Light**
Infiltration: **None** Pipe Seal Cond: **Sound**

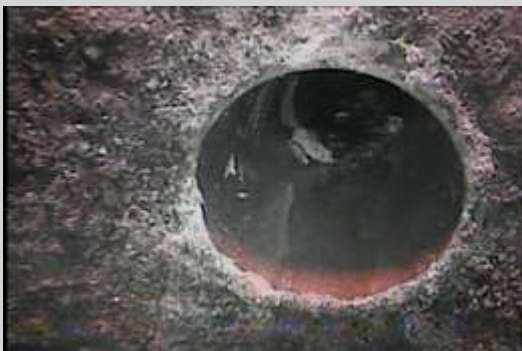
3 O'Clock Inflow

Pipe Height: **8.4** (in.) Rod and Bar (Angled)
Pipe Material: **Clay** ☐ Pipe Lined
Invert Depth: **7.98** (ft.) Flow Characteristics: **None**
Deposits: ☐ None ☐ Mud ☐ Sludge ☒ **Debris** ☐ Grease
Silt Depth: **7** (in.) Deposits Extent: **Heavy**
Infiltration: **None** Pipe Seal Cond: **Sound**

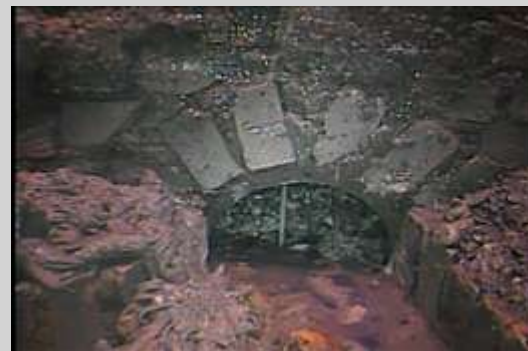
Drop In @ 3 O'Clock

Drop: **Outside** Rod and Bar
Angled: **Yes** Reading: **9.76** (ft.)
Inv Depth: **10.76** (ft.)
Drop Condition: **Clogged**
